CIVIL AERONAUTICS BOARD

AIRCRAFT ACCIDENT REPORT

TRANS WORLD AIRLINES, INC., LOCKHEED CONSTELLATION, MODEL 049,
N 86511, MIDWAY AIRPORT, CHICAGO, ILLINOIS
SEPTEMBER 1, 1961

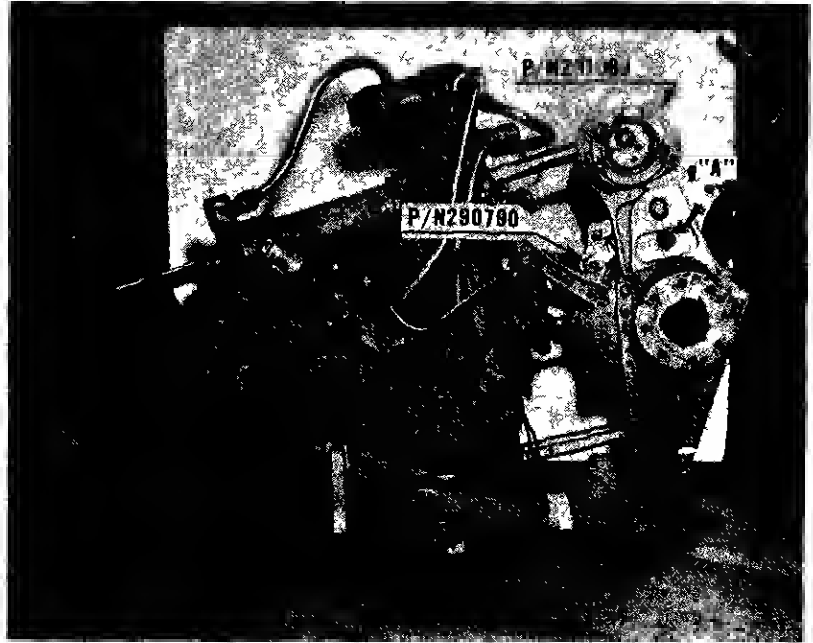
Examination of the parallelogram linkage of the elevator boost located in the extreme aft section of the fuselage revealed a 5/16-inch AN-175-21 nickel steel bolt to be missing. (See Appendix A, Fig. 1.) This parallelogram linkage connects the pilot elevator input to the control valve of the elevator boost system. The bolt was not found in the wreckage despite a thorough search, including sifting of earth in the wreckage area.

FIG. 1. Elevator boost package. Bushing where bolt should have been is indicated by arrow "A".

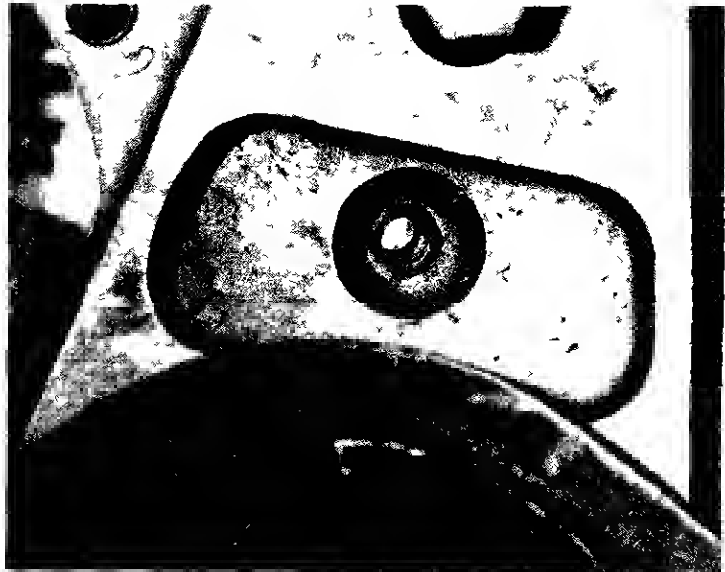
The arm assemblies, part No. 291089L, part No. 291089R, and link assembly, part No. 290790 (See Appendix A, Fig. 1), were examined to determine if the bolt was in place at time of impact. This bolt, when in its proper position, passes through the press-fit bushings of P/N 291089 arm assemblies and the P/N 290790 link assembly. The head of the bolt is installed against the outboard face of arm assembly P/N 291089L. On the outboard face of the bushing, which is flush with the face of the forged arm, there were two deposits of old thick grease having the consistency of modeling clay and 0.01 inch or more deep. (See Appendix A, Fig. 2.) The larger of the two grease deposits covered an arc of 120 degrees from the 11:00 to the 3:00 o'clock positions, ^{2/} and averaged 3/32 inch in width. The inner edge of this deposit was common with the inner circumference of the bushing, whereas the outer edge was, in places, slightly beyond the bushing's outer circumference; however, a slight outline of two sides of the bolt's hex-head was visible around its outer perimeter of the deposit. (See Appendix A, Fig. 2.)

FIG. 2. Close-up view before disassembly of bushing against which head of bolt should have been.

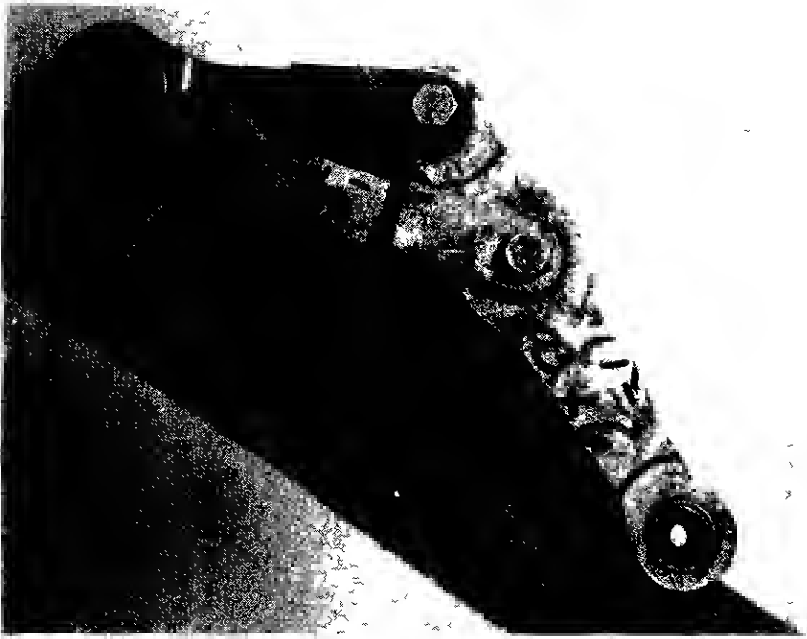
FIG. 5. Parallelogram, removed from boost assembly but reoriented to its position before removal. Note grease ring at arrow, made by bushing face.

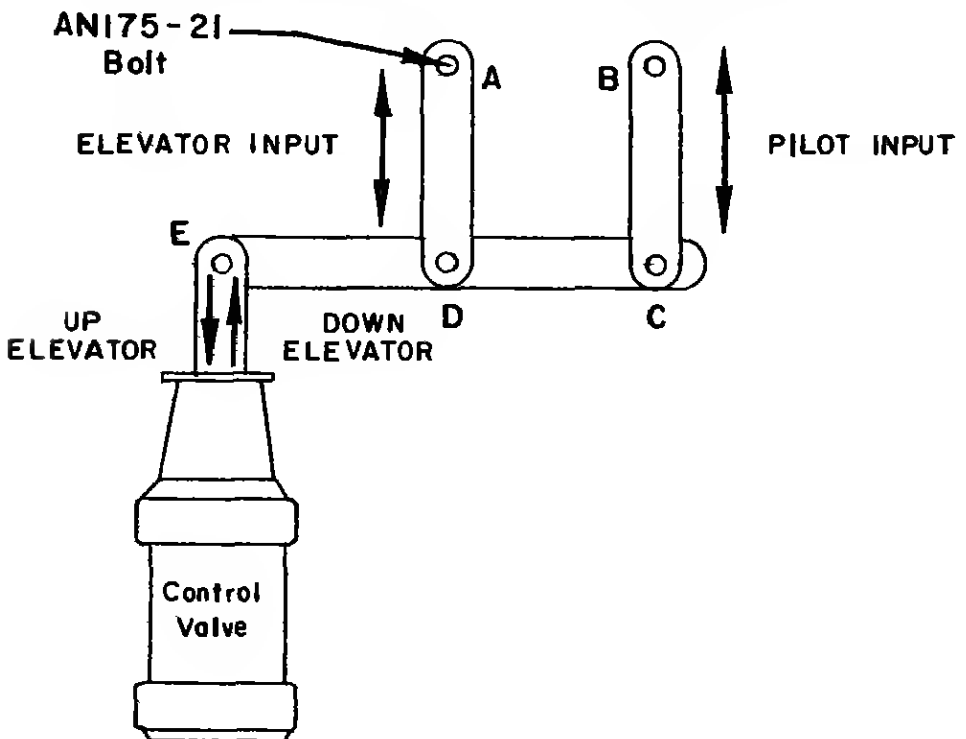
With reference to Appendix A, Fig. 6, it can be seen that pilot input moves link BC up or down which pivots link EDC as a walking beam about point D, causing point E to move down or up. This positions the control valve spool which is connected at point E. Elevator input moves link AD up or down which, in turn, pivots link EDC about point C. This action also positions the control valve spool. It should be noted that pilot and elevator inputs in the same direction are subtractive and inputs in opposite directions are additive to the valve spool.

If the AN-175-21 bolt at point A be removed, no support for the parallelogram is provided by link AD, and link EDC is free to pivot about point C. Since the valve is mounted in a near-vertical position, the weight of links AD and EDC and the weight of the spool are applied in the direction to move the spool toward up-elevator, to be resisted only by the friction in the valve and at points C and E, the total of which is negligible. Any friction above the normal would be overcome by vibration.

FIG. 6. Schematic diagram of parallelogram linkage and valve of elevator boost package.

On November 22, 1961, the Board recommended to the Administrator of the Federal Aviation Agency that the mechanism for shift-to-manual in the Constellation control boost system be modified so that the actions would be sequential rather than simultaneous. Specifically, under the recommended change, the shifting action by the pilot would remain one continuous motion of a handle but would, first, open the bypass valve; second, close the hydraulic shutoff valve and, third, shift the mechanical linkage. With such an arrangement, all hydraulic pressure in the boost package would be relieved prior to the mechanical shift action and would thus allow the complete shift-to-manual without restriction regardless of pilot-applied control forces.
